**Products Affected:**

The following products shipped prior to February 21st, 2006 are affected:  
CTI# 5520 WDS 15A Dimmer  
CTI# 5522 WDS 30A Dimmer  
CTI# 5515 WDS Personal Dimmer

**Overview:**

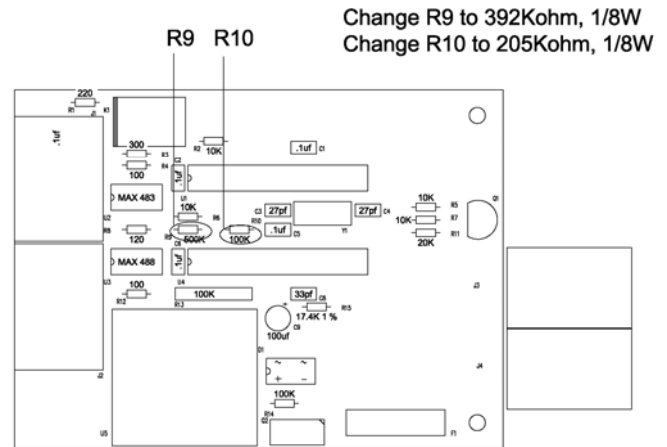
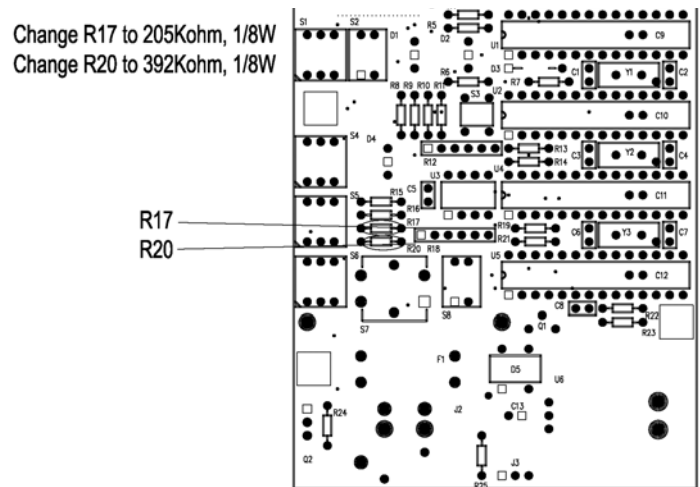
Two resistor values have been changed to reduce the sensitivity of the low voltage detection circuit. On the 5520 and 5522, the resistors affected are located at reference designator R9 and R10. On the 5515 the resistors are located at R17 and R20. The original value of R9 and R17 was 500KΩ and the original value of R10 and R20 was 100KΩ. These values have been changed to 392KΩ and 205KΩ respectively. This change will reduce the low voltage threshold from 10VDC to 7VDC.

While this modification will reduce the threshold at which the dimmer goes into the low voltage error, it will not eliminate this function altogether. For optimum performance, it is recommended that properly sized and maintained batteries be used. In addition, if a quick bump on a large load is required, it is recommend to first “preheat” the load at a very low level. This will reduce the inrush current when the load is bumped to full, and keep the battery at a higher voltage.
