Products Affected:

The following products shipped prior to February 21st, 2006 are affected:
CTI# 5520 WDS 15A Dimmer
CTI# 5522 WDS 30A Dimmer
CTI# 5515 WDS Personal Dimmer

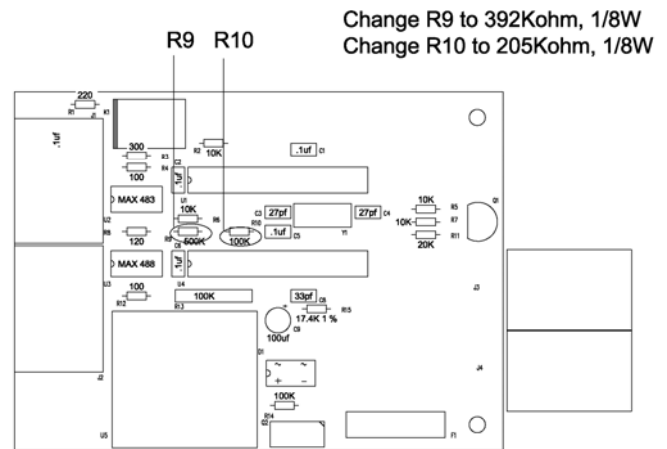
Two resistor values have been changed to reduce the sensitivity of the low voltage detection circuit. On the 5520 and 5522, the resistors affected are located at reference designator R9 and R10. On the 5515 the resistors are located at R17 and R20. The original value of R9 and R17 was 500KΩ and the original value of R10 and R20 was 100KΩ. These values have been changed to 392KΩ and 205KΩ respectively. This change will reduce the low voltage threshold from 10VDC to 7VDC.

While this modification will reduce the threshold at which the dimmer goes into the low voltage error, it will not eliminate this function altogether. For optimum performance, it is recommended that properly sized and maintained batteries be used. In addition, if a quick bump on a large load is required, it is recommend to first “preheat” the load at a very low level. This will reduce the inrush current when the load is bumped to full, and keep the battery at a higher voltage.
